Manhole Inspection Summary

Manhole # S55O__034MH

Insp Date: **1/13/09 10:06 AM**

Location Address: **3701 odonnell st**

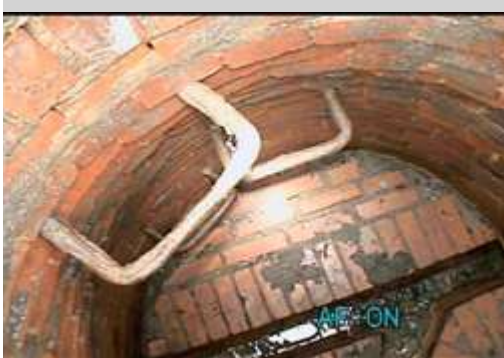
Defect 2

Count: **3** Missing: **0** ☒ **Corroded**

corr steps

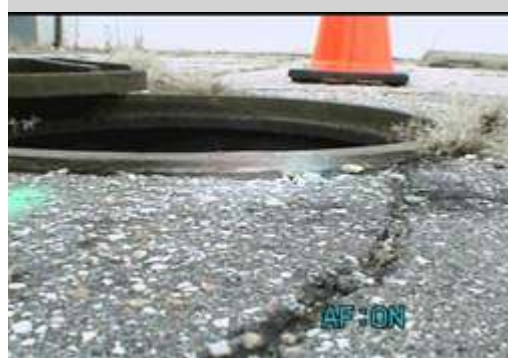
Defect 1

Diameter: **24** (in.) Length: **0** (in.) Dist A/B Grade: **1** (in.)

above grade

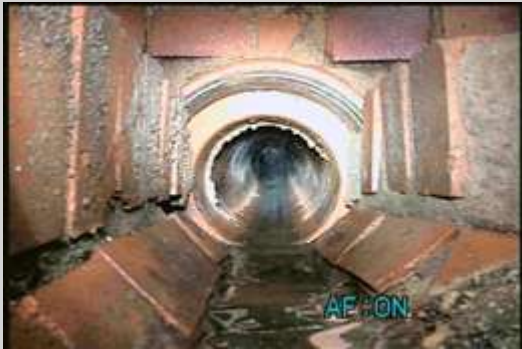
12 O'Clock Outflow

6 in. Circular Gravity Sewer
Pipe Out @ 12 O'Clock

Pipe Material: **Clay** ☐ Pipe Lined

Invert Depth: **6.83** (ft.) Flow Characteristics: **Slow**

Infiltration: **None** Pipe Seal Cond: **Unknown**

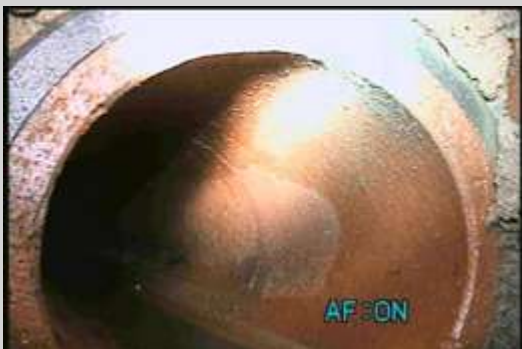
3 O'Clock Inflow

6 in. Circular Gravity Sewer
Pipe In @ 3 O'Clock

Pipe Material: **Clay** ☐ Pipe Lined

Invert Depth: **6.75** (ft.) Flow Characteristics: **Slow**

Infiltration: **None** Pipe Seal Cond: **Unknown**

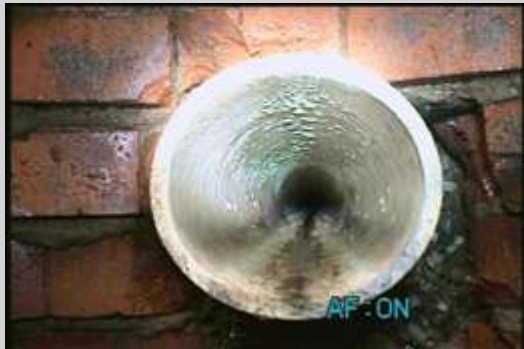
Pipe In @ 6 OClock

6 in. Circular Gravity Sewer

Pipe Material: **Clay** ☐ Pipe Lined

Invert Depth: **2.75** (ft.) Flow Characteristics: **Slow**

Infiltration: **None**

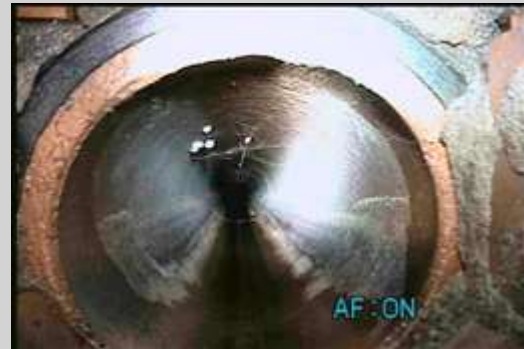
Drop In @ 6 OClock

Drop: **Outside Direct**

Inv Depth: **6.70** (ft.)

Drop Condition: **Open**
